**METALLURGICAL EVALUATION OF
A DOT-E6498-2216 CYLINDER**
FaAA Project No.: DC17916.000

Timothy R. Smith, Ph.D., P.E.
Failure Analysis Associates, Inc.
310 Montgomery Street
Alexandria, VA 22314

January 1997

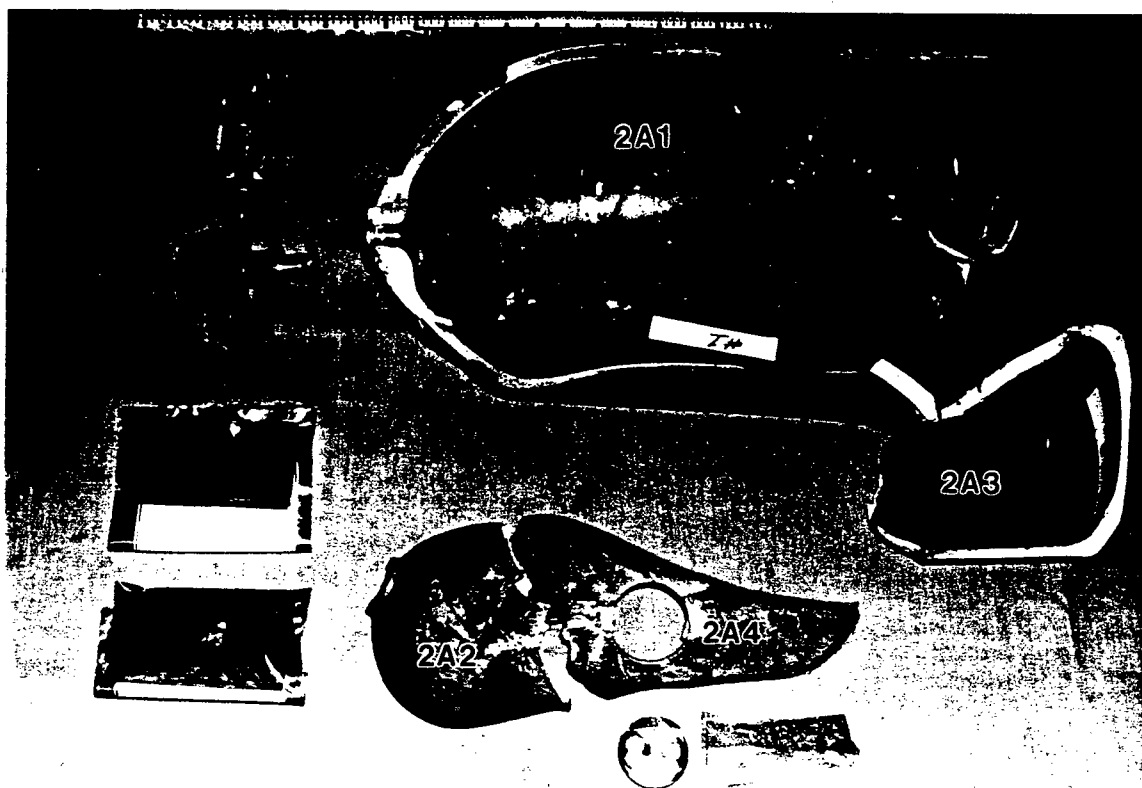
A visual examination of the cylinder remains was performed. The remains are shown in Figure 1, in the as-received condition. The cylinder broke apart into four large pieces and at least two small fragments. At the time of FaAA's inspection, a circular sample of material had been cut from one piece and contained burn markings, presumably from tests by optical emission spectroscopy to determine its bulk chemistry. In addition, some aluminum chips, presumably from drilled holes at unknown location(s), were also included in the remains.

Figure 1. Remains of the cylinder, as received.
Photo ID: DC17916-R4E6.

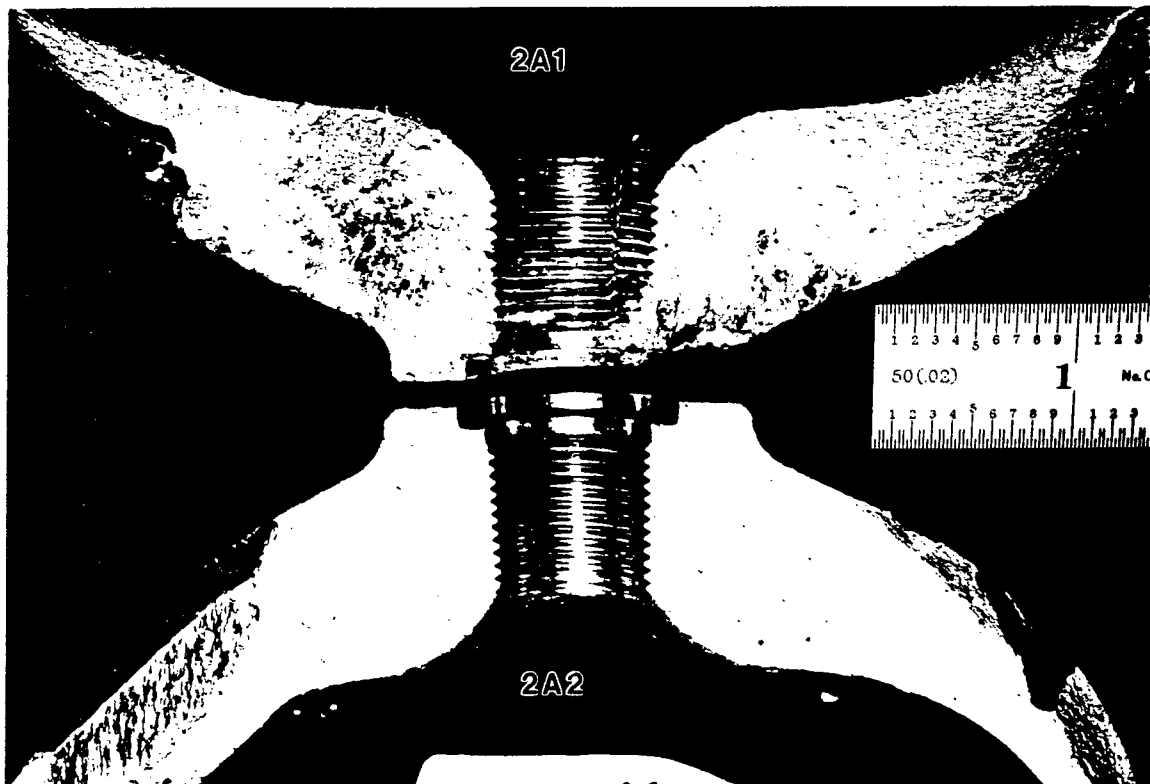
The fracture surfaces of the cylinder were inclined (i.e., non-radial with respect to the cylinder axis) shear-type, except in the neck region where the fracture surfaces were flat and radial with respect to the axis of the cylinder. The main fracture surface ran through essentially a full diameter of the inlet hole in the neck region. Figure 2 shows the matching halves of the fracture surface from the neck region (fragments 2A-1 and 2A-2). The larger of the two pieces (2A-1) had foreign contamination on the fracture surface on both sides of the inlet hole. This contamination appeared to be paint and either concrete dust or plaster. This piece also showed impact damage to the fracture surface at the inlet

hole, presumably a result of the pressurized cylinder rupture. Other pieces also showed impact damage at certain locations, all appearing to be from the rupture event.

Figure 2. Mating fracture surfaces (fragments 2A-1 and 2A-2) at the inlet hole. Note the fracture is planar in the neck region.
Photo ID: DC17916-R5E5.

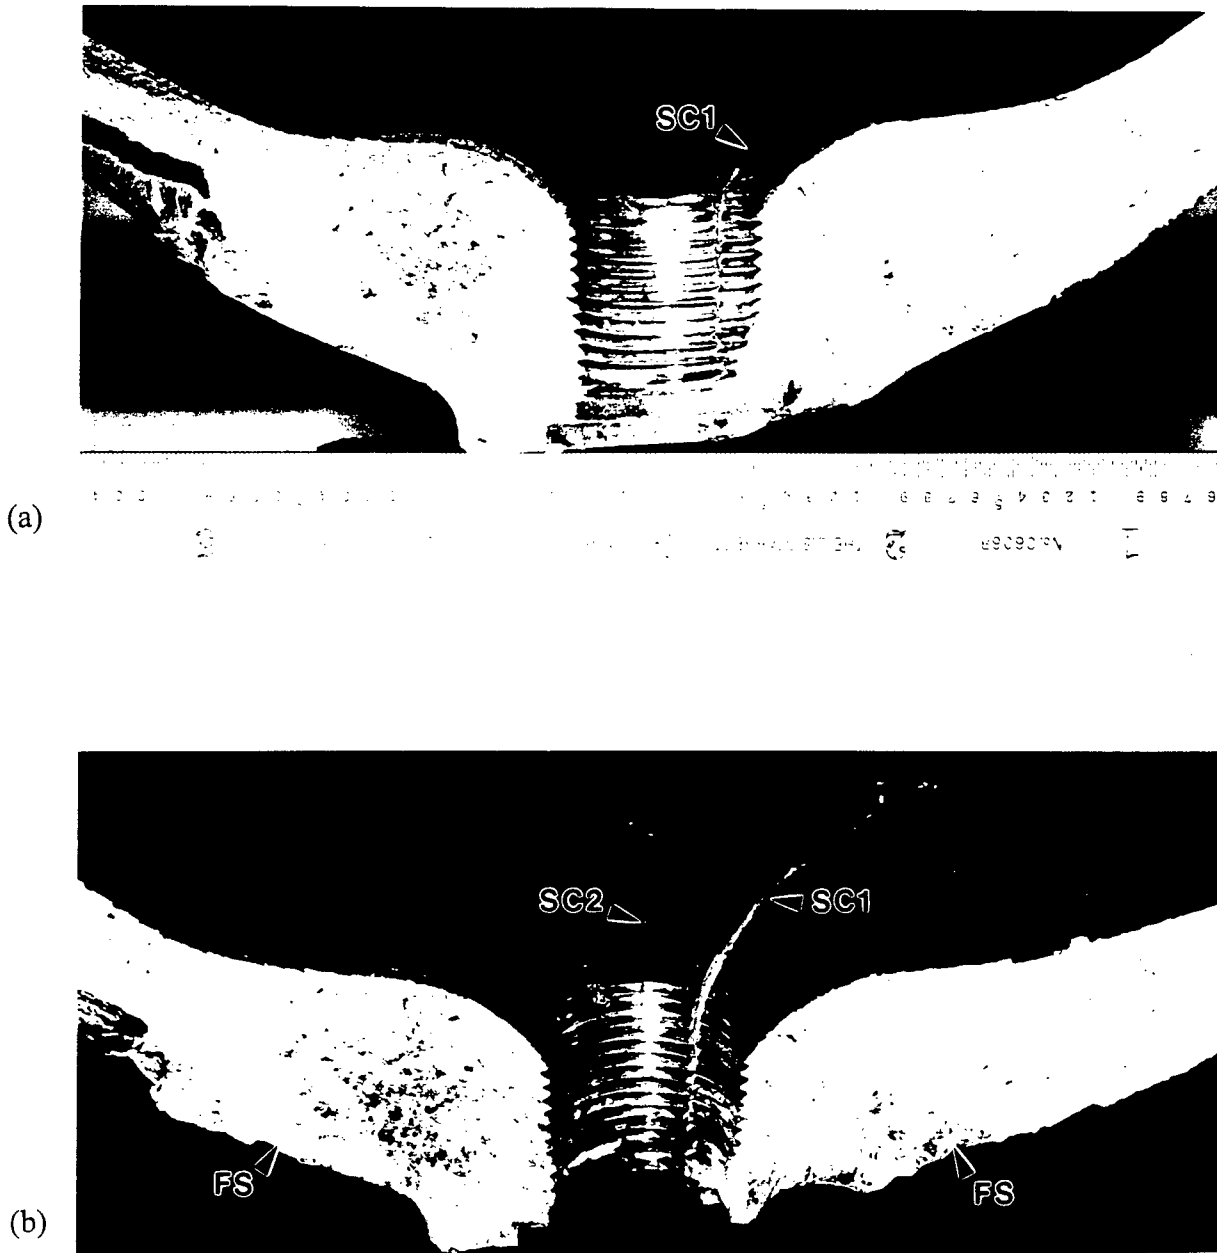
Figure 3 shows two views of the fracture surface of fragment 2A-1 from the neck region. The inside wall of the cylinder in this region shows multiple folds (or cusps) from the original manufacturing process. The fracture surface on both sides of the inlet hole appears to pass through deep folds of this type. On fragment 2A-1, there were at least two large cracks, labeled SC1 and SC2 on Figure 3, originating from these folds.

Figure 3. Fragment 2A-1 fracture surface, neck region.
 (a) View perpendicular to fracture surface.
 Photo ID: DC17916-R4E20.
 (b) View inclined to fracture surface.
 Photo ID: DC17916-R4E21.
 Note: FS marks the fracture surface, SC1 and SC2
 are secondary cracks.

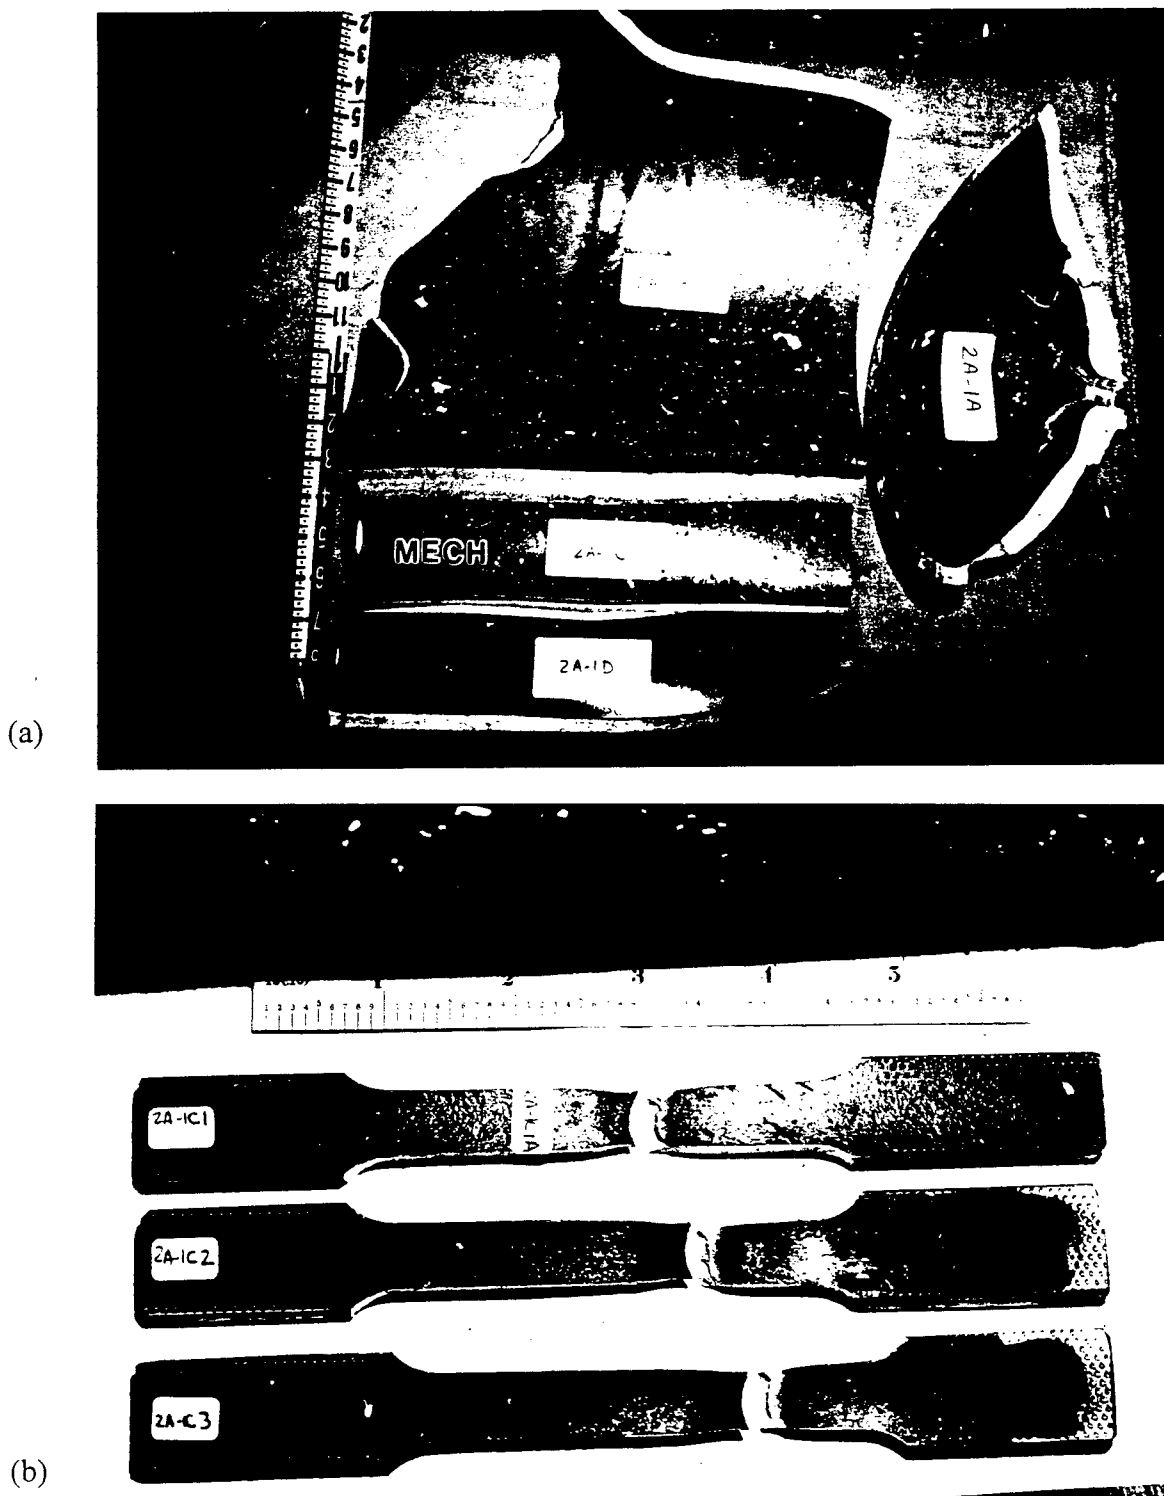
Standard size ASTM 370 tensile test coupons from the cylinder wall, aligned along the cylinder axis, were tested at room temperature. Fragment 2A-1 was sectioned, Figure 4(a), and component 2A-1C was used for tensile test coupons, as it contained material minimally deformed by the cylinder rupture. Three full-thickness coupons were chosen and Figure 4(b) shows them in the post-tested configuration. The test data are shown in Table 3.

Figure 4. Cylinder fragment 2A-1.
 (a) Sections cut. Mech denotes the piece used for machining tensile test coupons.
 Photo ID: DC17916-R12E1.
 (b) Tensile test coupons in the post-tested condition.
 Photo ID: DC17916-R11E21.

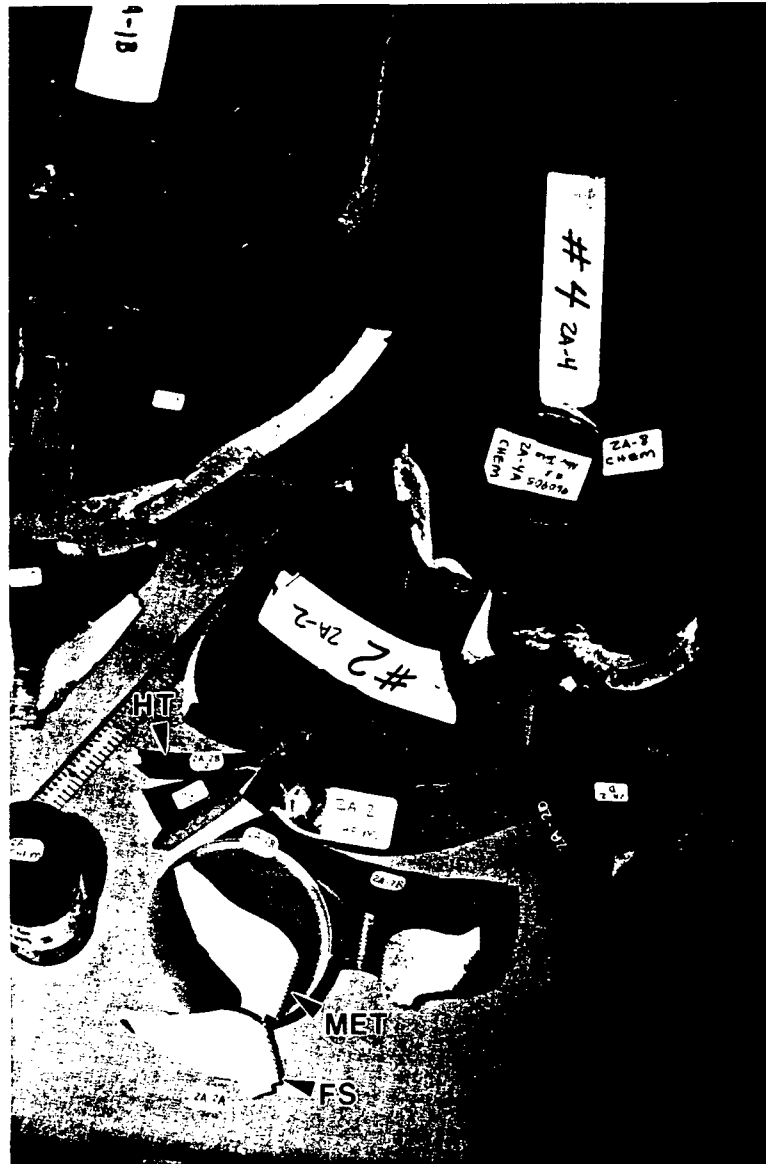
Figure 5 shows the sections cut from cylinder fragments 2A-2 and 2A-4. A section of the fracture surface was cut from cylinder fragment 2A-2 that removed the flat-faced portion on one side of the inlet hole. A wafer approximately 0.05 inch thick was generated ("FS" in Figure 5) in this process. The remaining piece was then sectioned in a parallel slice, as close as possible to the previous cut. This section was then polished and etched to reveal

its structure ("MET" in Figure 5). This polished metallurgical section should have a microstructure virtually identical to that at the fracture surface itself.

Figure 5. Sectioning of fragments 2A-2 and 2A-4.
Photo ID: DC17916-R4E6.

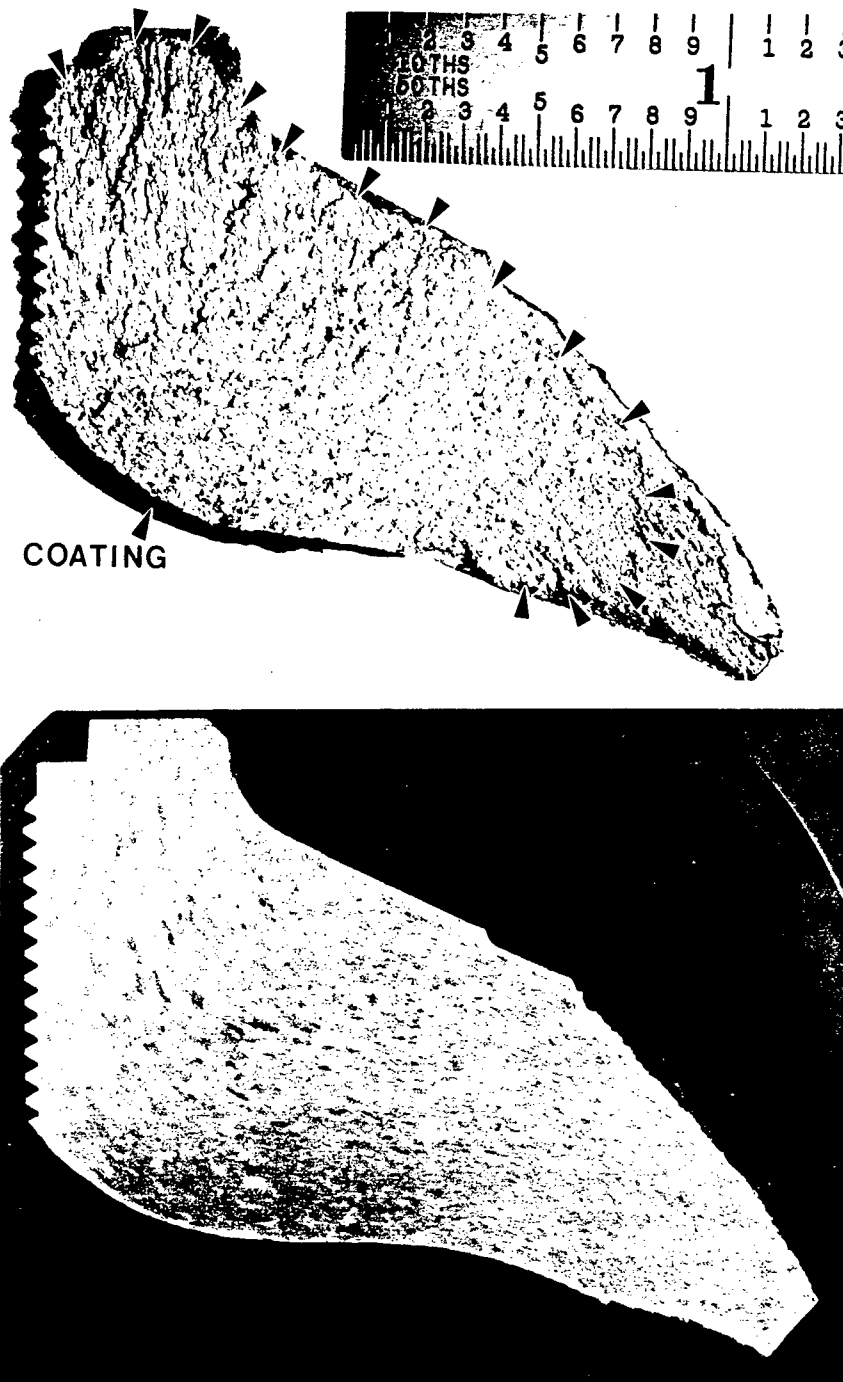
Figure 6. Wafers FS and MET from Figure 5.

Figure 6(a) shows the wafer containing the fracture surface from Figure 5 and Figure 6(b) shows the etched macrostructure of the same region from the second wafer sliced parallel to the fracture surface. Some correspondence between features on the fracture surface and the grains is seen. Note that the grain size is relatively small, compared to the thickness at the neck.

The location of a beach mark on the fracture surface segment studied in detail (Figures 6 and 12) suggests that this crack propagated sub-critically (i.e., slowly) for the majority of the flat-faced region up to the extent defined by the beach mark. A similar, but perhaps less defined beach mark is present on the opposite side of the inlet hole. These beach marks are consistent with the morphology of cracked regions at the neck of other DOT-6498, DOT-3Al, and DOT-7235 aluminum cylinders that were rejected during hydrostatic retesting [4] and with an Australian-specification aluminum cylinder that leaked during filling [5]. This morphology is also consistent with the fracture surface of a DOT-3AL cylinder that ruptured during filling, provided for FaAA's examination by J. H. Smith of the National Institute of Science and Technology [6].

(a) Portion of flat-faced fracture surface from neck region of fragment 2A-1. Photo ID: DC17916-TRS-1-01/14/97.

(b) Macrostructure of neck region of fragment 2A-1. HF/H₂SO₄/H₂O etch. Photo ID:DC17916-PAL-1-10/31/96. Scale is in 0.02 inch increments.

Note: Inside cylinder coating on the fracture surface as shown. Unlabeled arrows define an apparent beach mark on the fracture surface.

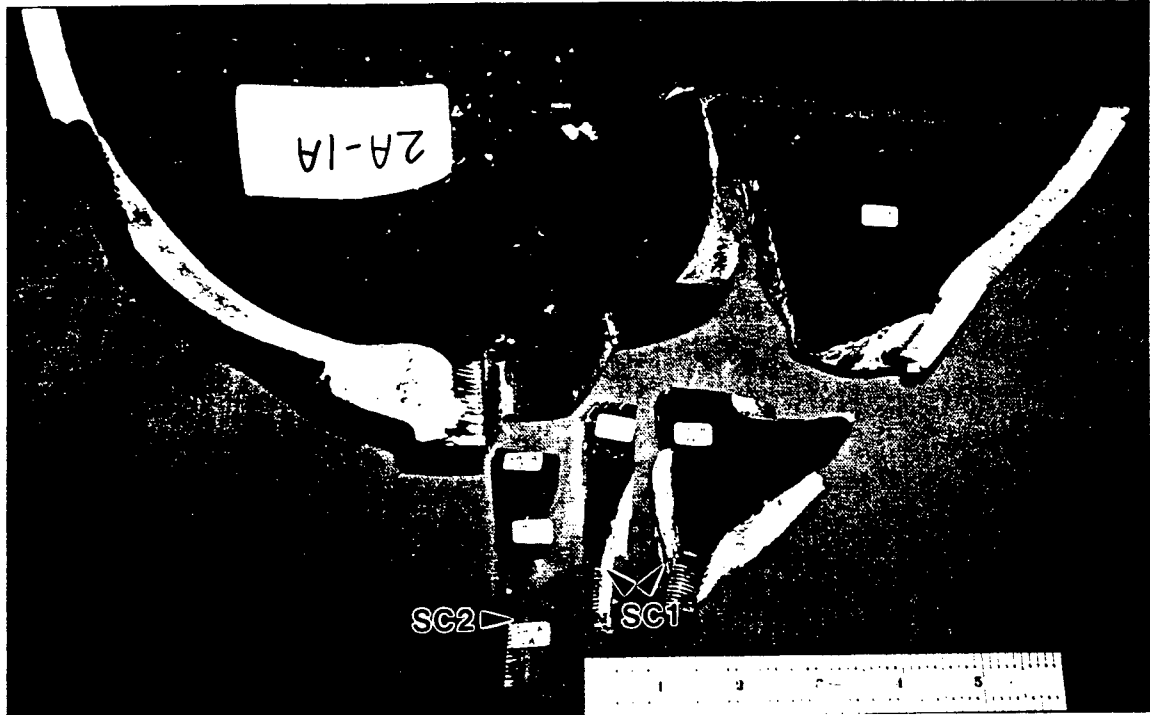
Figure 7 shows the sectioning performed on fragment 2A-1 from the neck region. The cracks, SC1 and SC2 (Figure 3), were selected for further study. Crack SC1 was forced open in the laboratory, after the remaining ligament was saw-cut part way through. The newly-formed fracture surfaces are shown in Figure 7. Crack SC2 was sectioned just below the inlet hole threads (section 2A-1A2B) and metallurgically polished to reveal its morphology.

Figure 7. Sectioning of fragment 2A-1 in the neck region.
Photo ID: DC17916-R11E2.
Note: The crack SC1 (see Figure 3) forced open in the laboratory and the crack SC2 contained within the sections 2A-1A2A and 2A-1A2B.

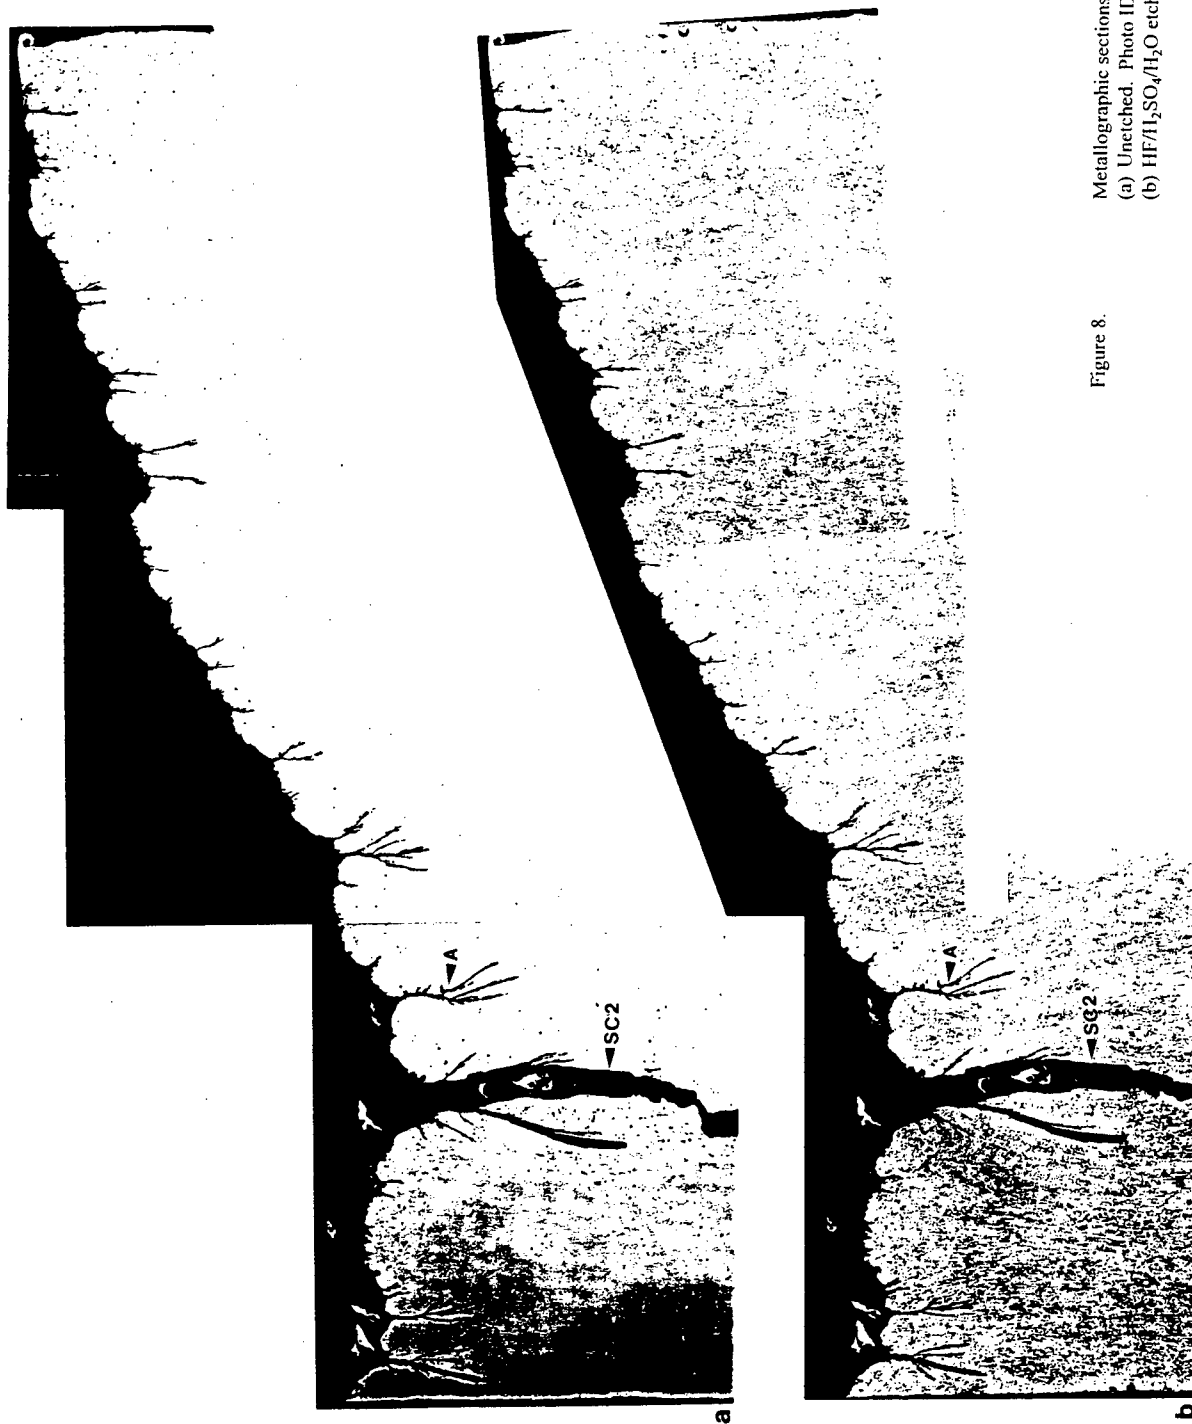
Figure 8 shows section 2A-1A2b containing crack SC2. Note the multiple folds at the inside surface and multiple branched cracks emanating from these folds. Figure 8(a) shows the section in the unetched condition and Figure 8(b) shows the microstructure after preparation with a $\text{HF}+\text{H}_2\text{SO}_4+\text{H}_2\text{O}$ etch. The microstructure is typical for AA6351 in the T6 temper condition. Figure 9 shows a higher magnification view of the crack marked "A" in Figure 8. Note that the main crack degenerates into multiple fine-scale branches.

Sectioning of the cylinder wall just below the threads at the inlet hole revealed multiple cracks from multiple origins at folds (or cusps) in the inside wall. These branched cracks are consistent with cracks found in the neck region of other DOT-6498, DOT-3Al, and DOT-7235 aluminum cylinders [4]. The possible association of cracks with AlFeSi compounds in the microstructure of the subject cylinder is consistent with other reported work on intergranular creep embrittlement of Al-Mg-Si alloys [3]. In this regard the observed cracks are consistent with studies of "sustained-load cracking" at ambient temperature reported in the literature for similar Al alloys [3, 7-9, 10-11].

Figure 8.
Metallographic sections of 2A-1A2B containing SC2. 50X.
(a) Unetched. Photo ID: DC17916-PAL-12.3-11/08/96.
(b) HF/H₂SO₄/H₂O etch. Photo ID: DC17916-PAL-4.5.6-11/08/96.

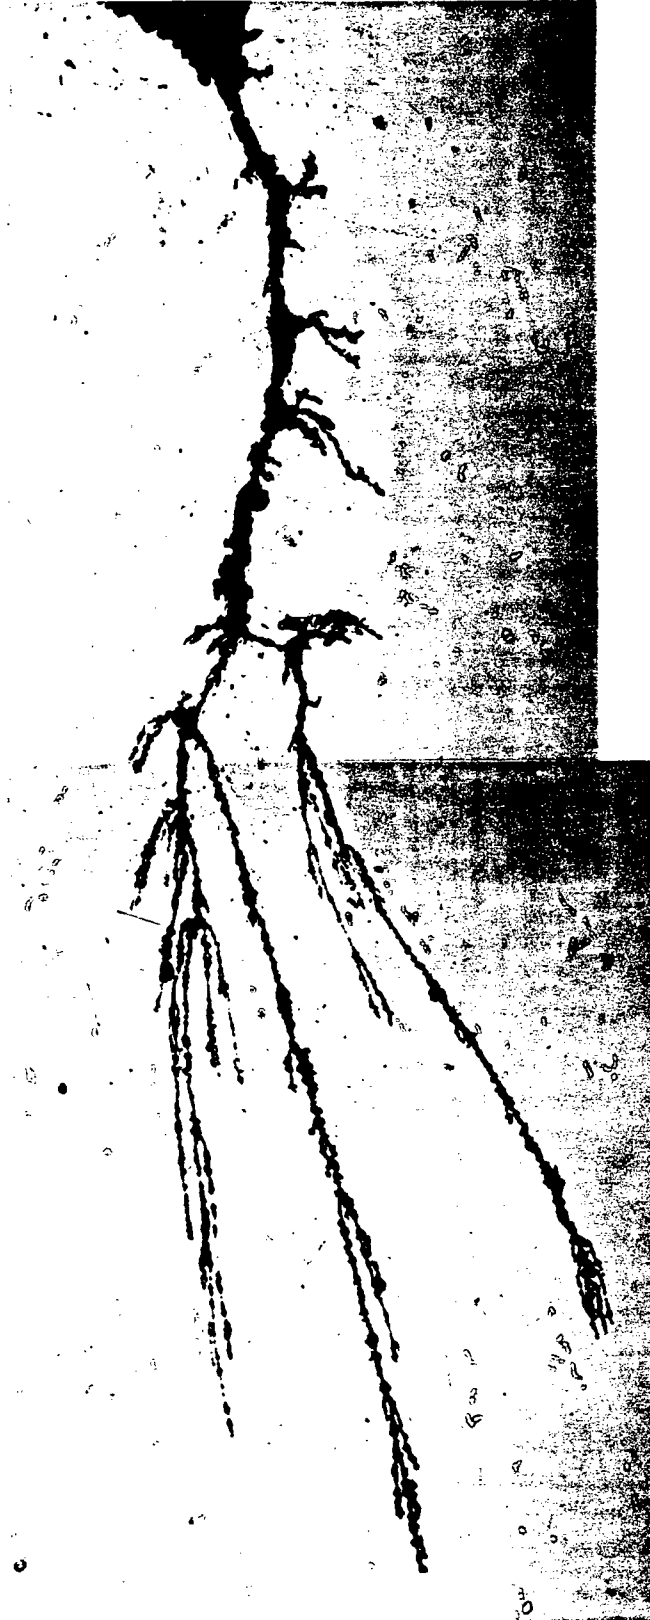
Figure 9. Close-up of crack "A" from Figure 8. 400X.
Unetched. Photo ID: DC17916-PAL-9,10-11/08/96.

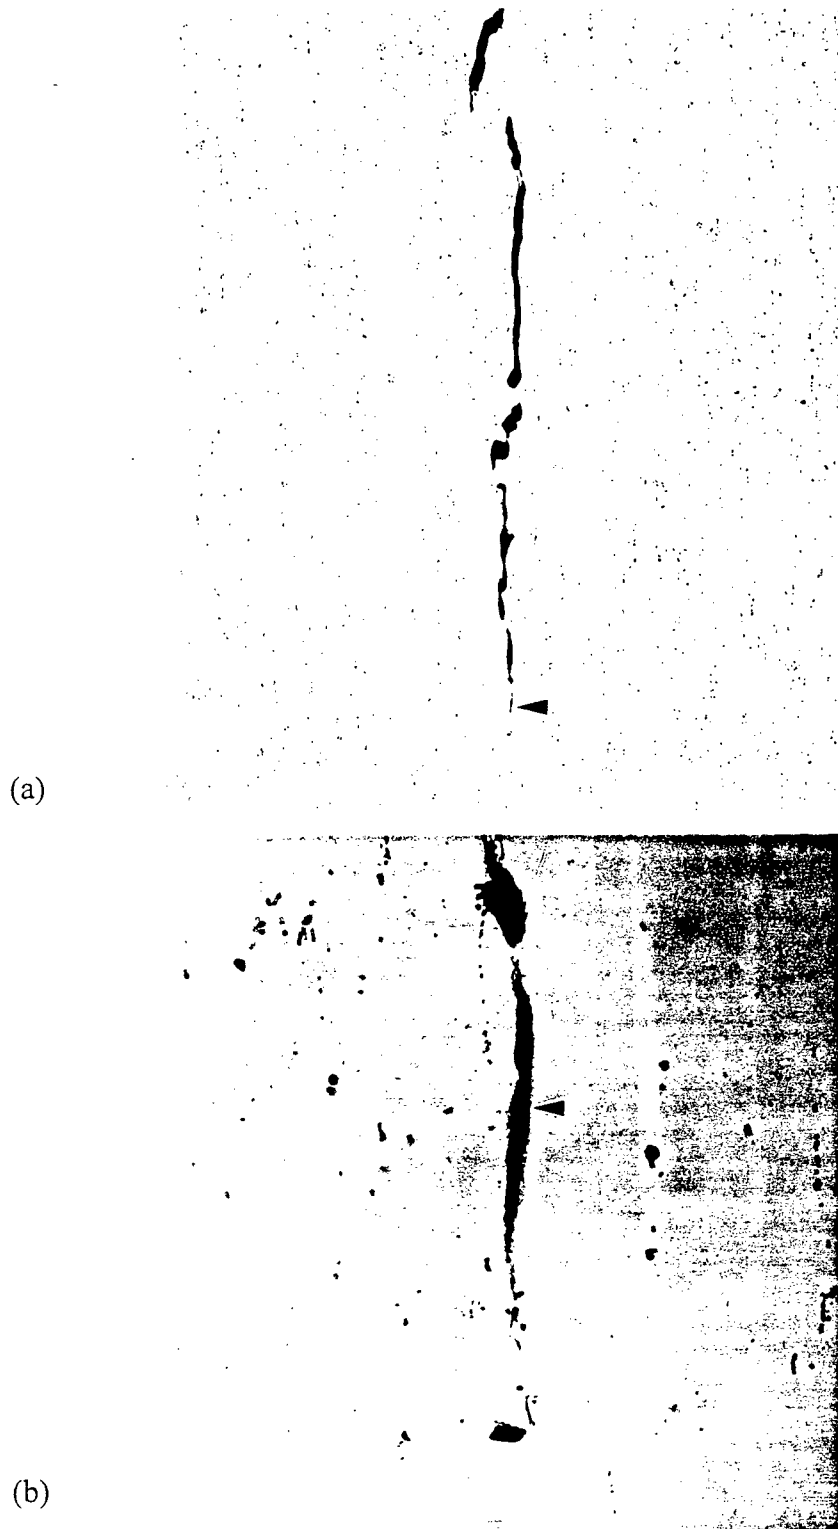
Figure 10. A crack tip from Figure 8.

Figure 10 shows the tip of a crack from the subject cylinder that was examined metallographically. Note that the crack appears to be discontinuous. Formation of the crack also appears to be associated with Mg_2Si and AlFeSi compounds in the microstructure, shown as the distributed darker grey phases in Figure 10. To determine if the cracks were associated with a particular type of inclusion, a polished metallographic section was examined in the scanning electron microscope (SEM) and the chemical composition of the inclusions probed by energy dispersive spectroscopy (EDS). Figure 11 shows the results of this analysis. Note that the majority of inclusions seen in this micrograph (such as A and C) contain Fe and Mn, and thus are expected to be of the AlFeSi type, a variant of which also contains Mn substitutionally for Fe [2]. Inclusion B, with strong Mg and Si peaks, appears to be Mg_2Si . While not conclusive, Figure 10 and 11 suggest that the cracks form along stringers of AlFeSi compounds.

(a) Tip region. 50X. Unetched.

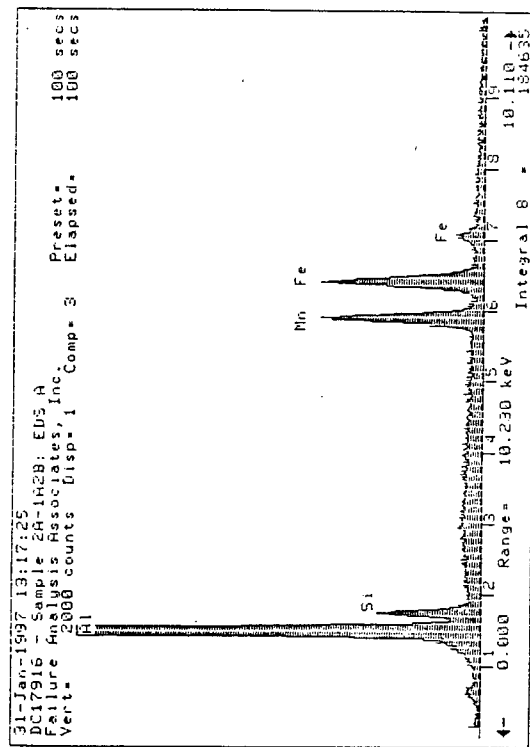
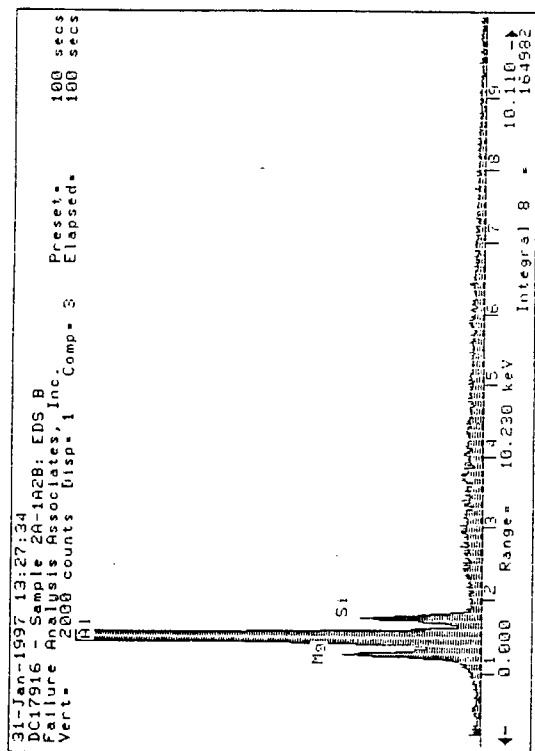
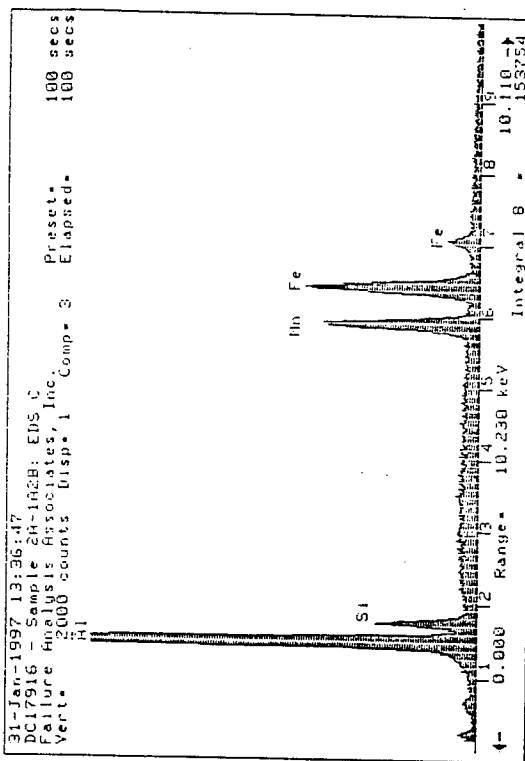
Figure 11. Precipitates near a crack tip.

- (a) SEM micrograph of a crack tip.
- (b) EDS spectrum of inclusion A.
- (c) EDS spectrum of inclusion B.
- (d) EDS spectrum of inclusion C.

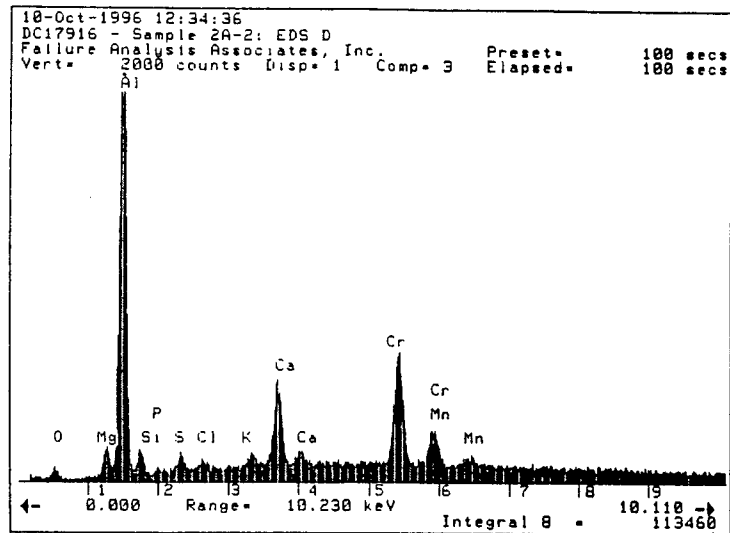
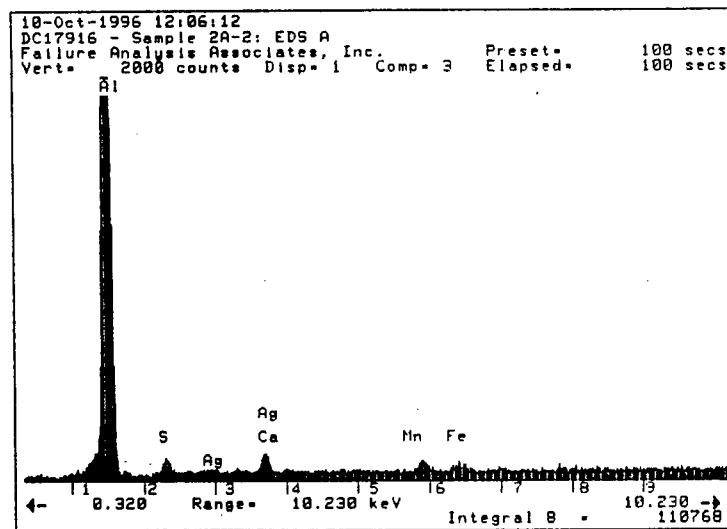
Figure 13. EDS Spectra captured from the flat-faced fracture surface.
 (a) Region 1.
 (b) Region 2.

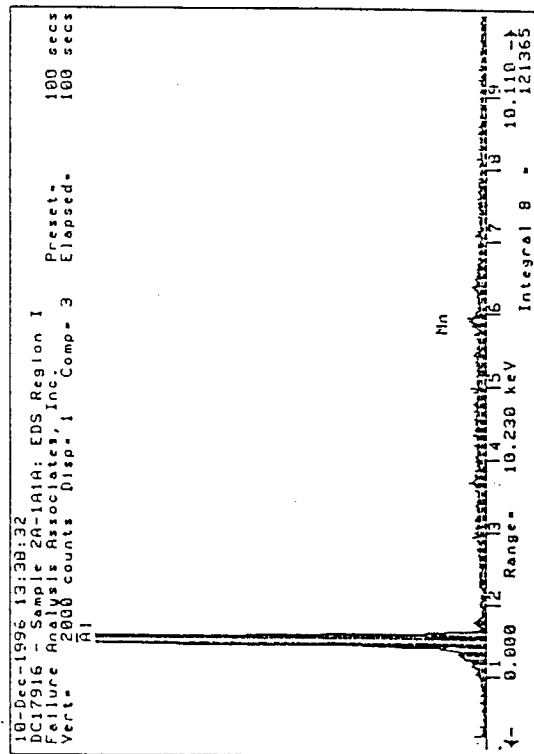
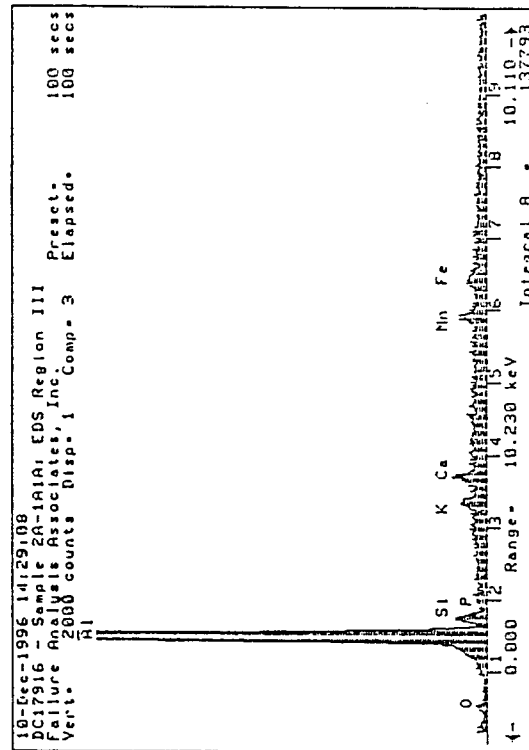
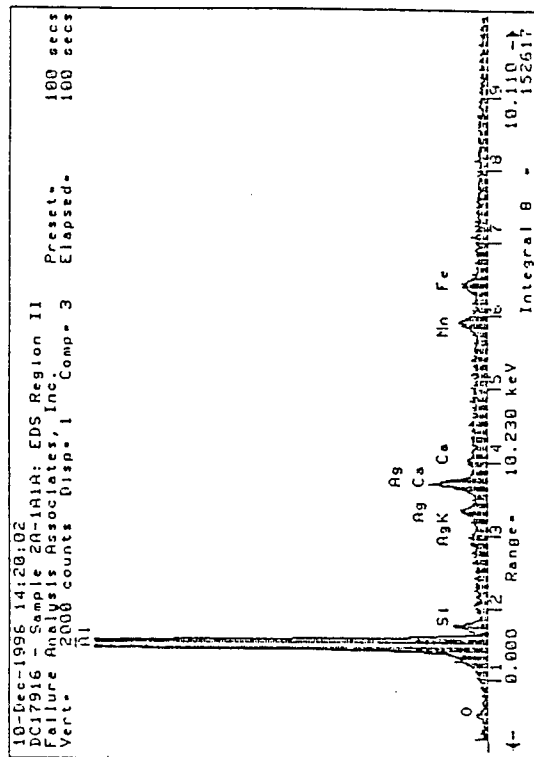
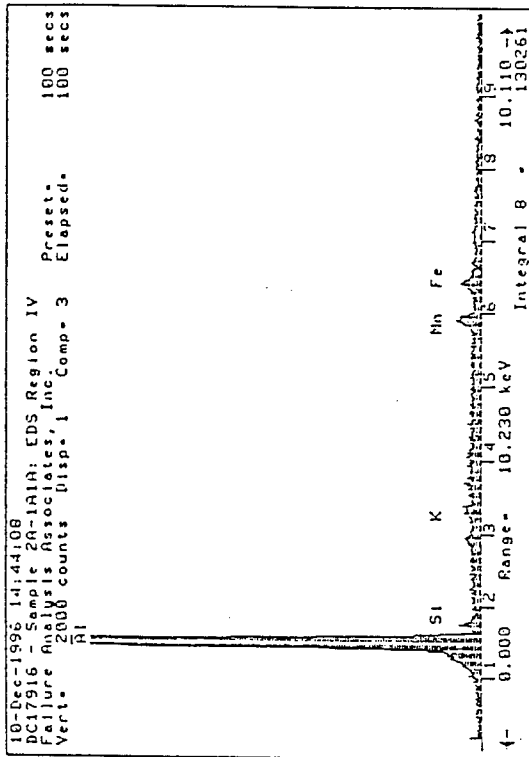
Figure 15. EDS Spectra from fracture surface shown in Figure 12.

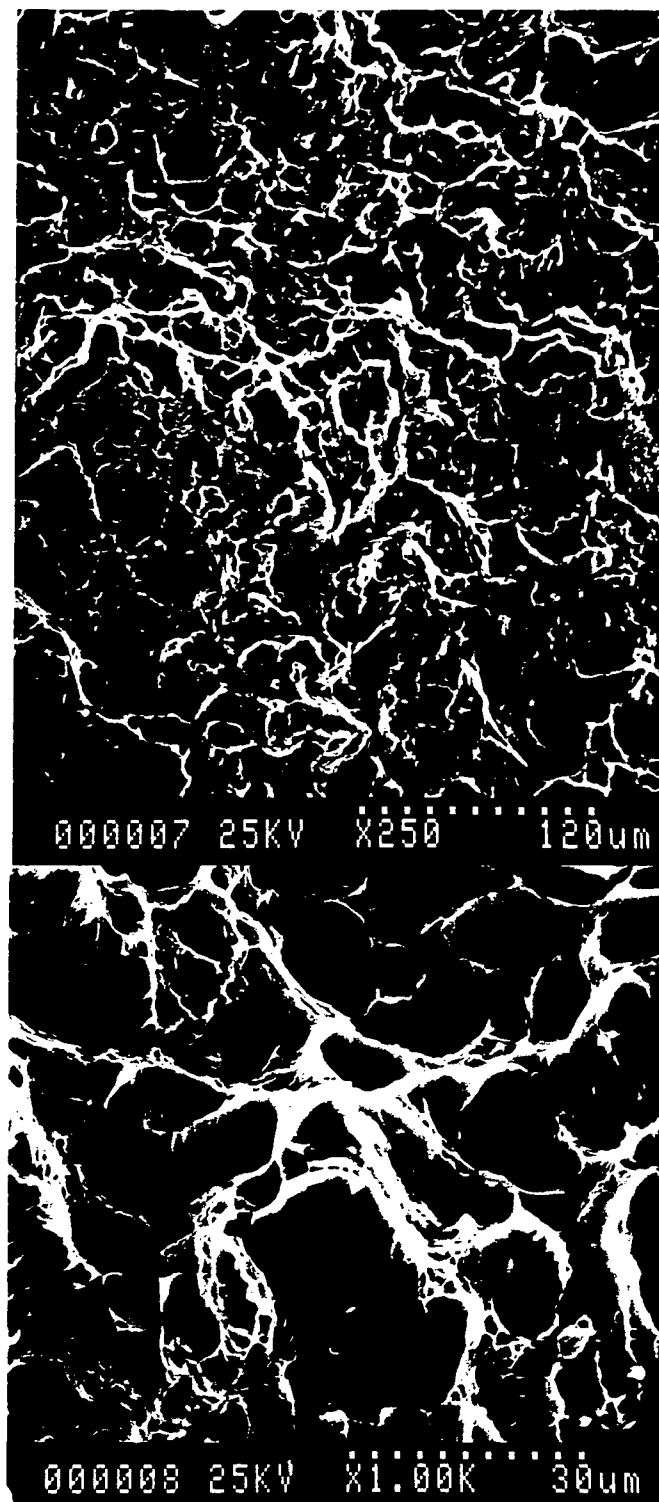
Figure 16.

Figure 16 shows SEM fractographs of the fracture surface from one of the tensile specimens (specimen 2A-1C1, Figure 4) used for mechanical property determination. Note that the fracture surface is primarily ductile dimpled rupture, with both macro and micro dimples, and some intergranular faceting, with microdimpling on these facets. This morphology is consistent with fractographic studies of similar Al alloys in tensile and toughness testing [3]. A comparison of the Figure 16 fractographs with Figures 12

and 14, indicates that there is no clear differentiation fractographically between tensile overload and a large portion of the flat-faced fracture surfaces, described above.

SEM fractographs of a tensile specimen.
